Natural Features Technical Memoranda

Appendix A1 – Desktop Natural Features Assessment

Project Name: Lake Huron Water Treatment Plant Disinfection and Storage Upgrades Class Environmental Assessment

Project Number: CE801200

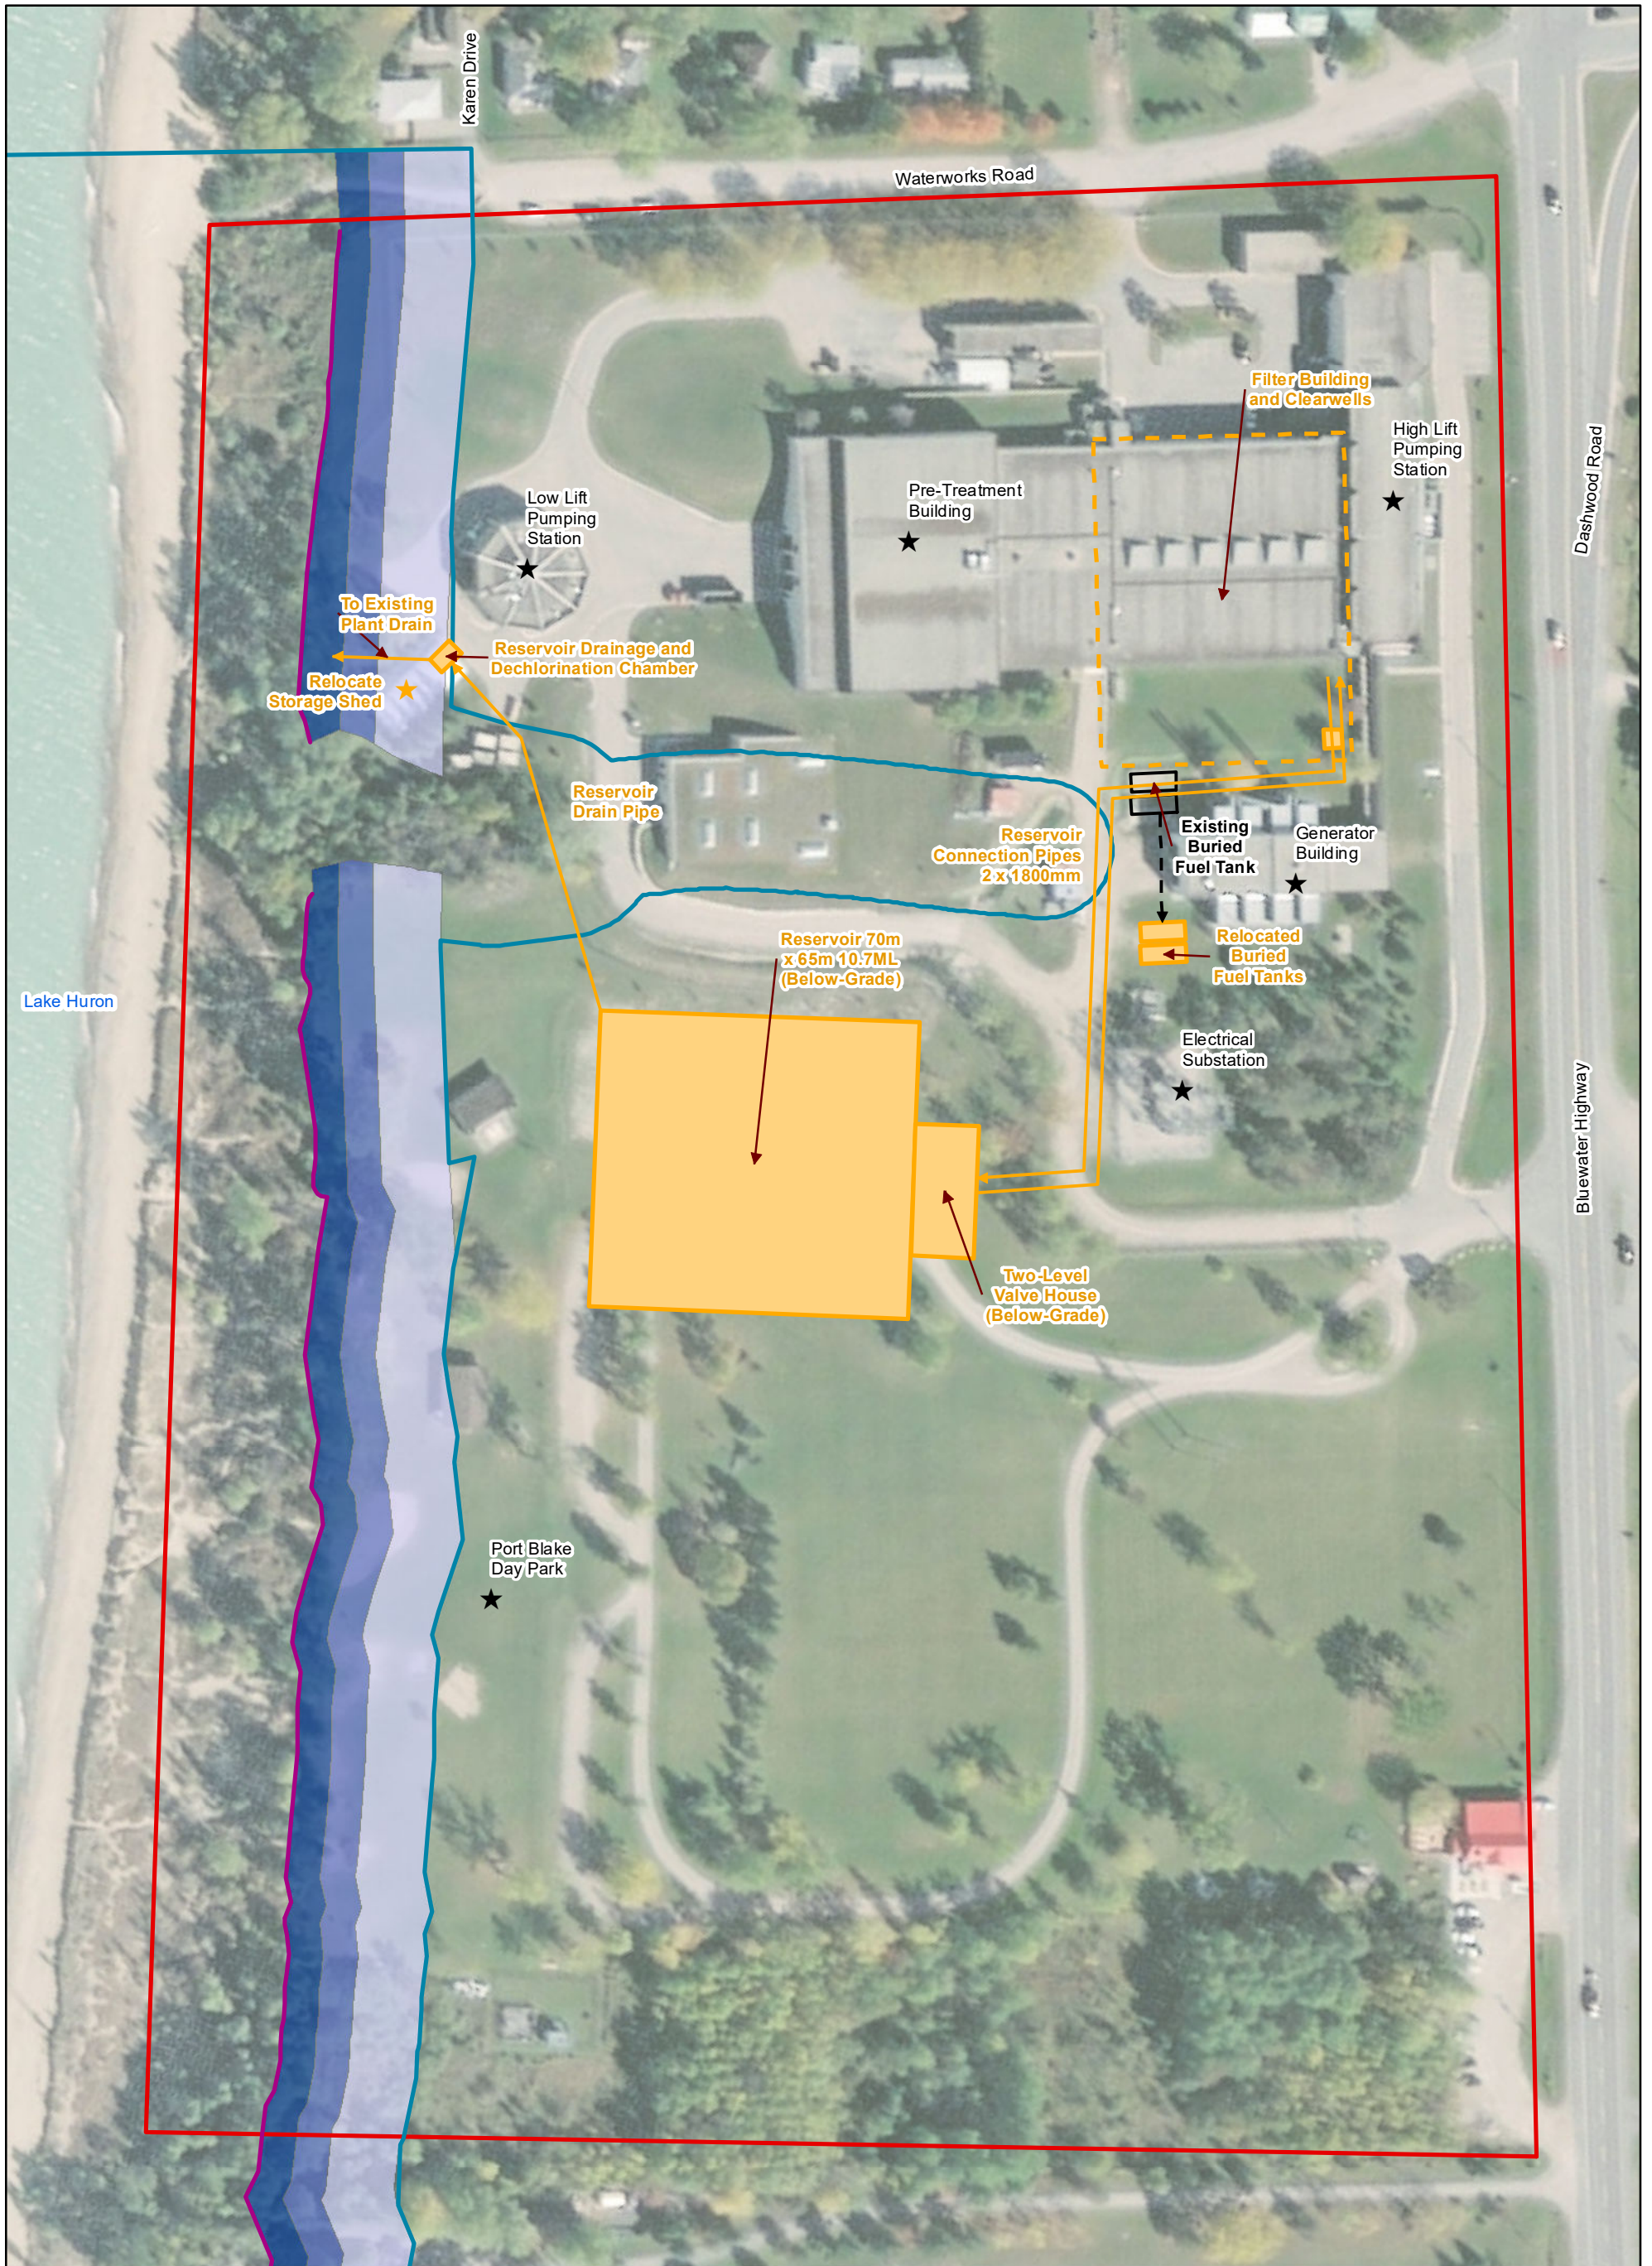
Figure 1
Alternative 2
Baseline Ecological Technical Memorandum
Lake Huron Water Treatment Plant Disinfection and Storage Upgrades EA
Lake Huron Primary Water Supply System
71155 Bluewater Hwy, Grand Bend, Ontario

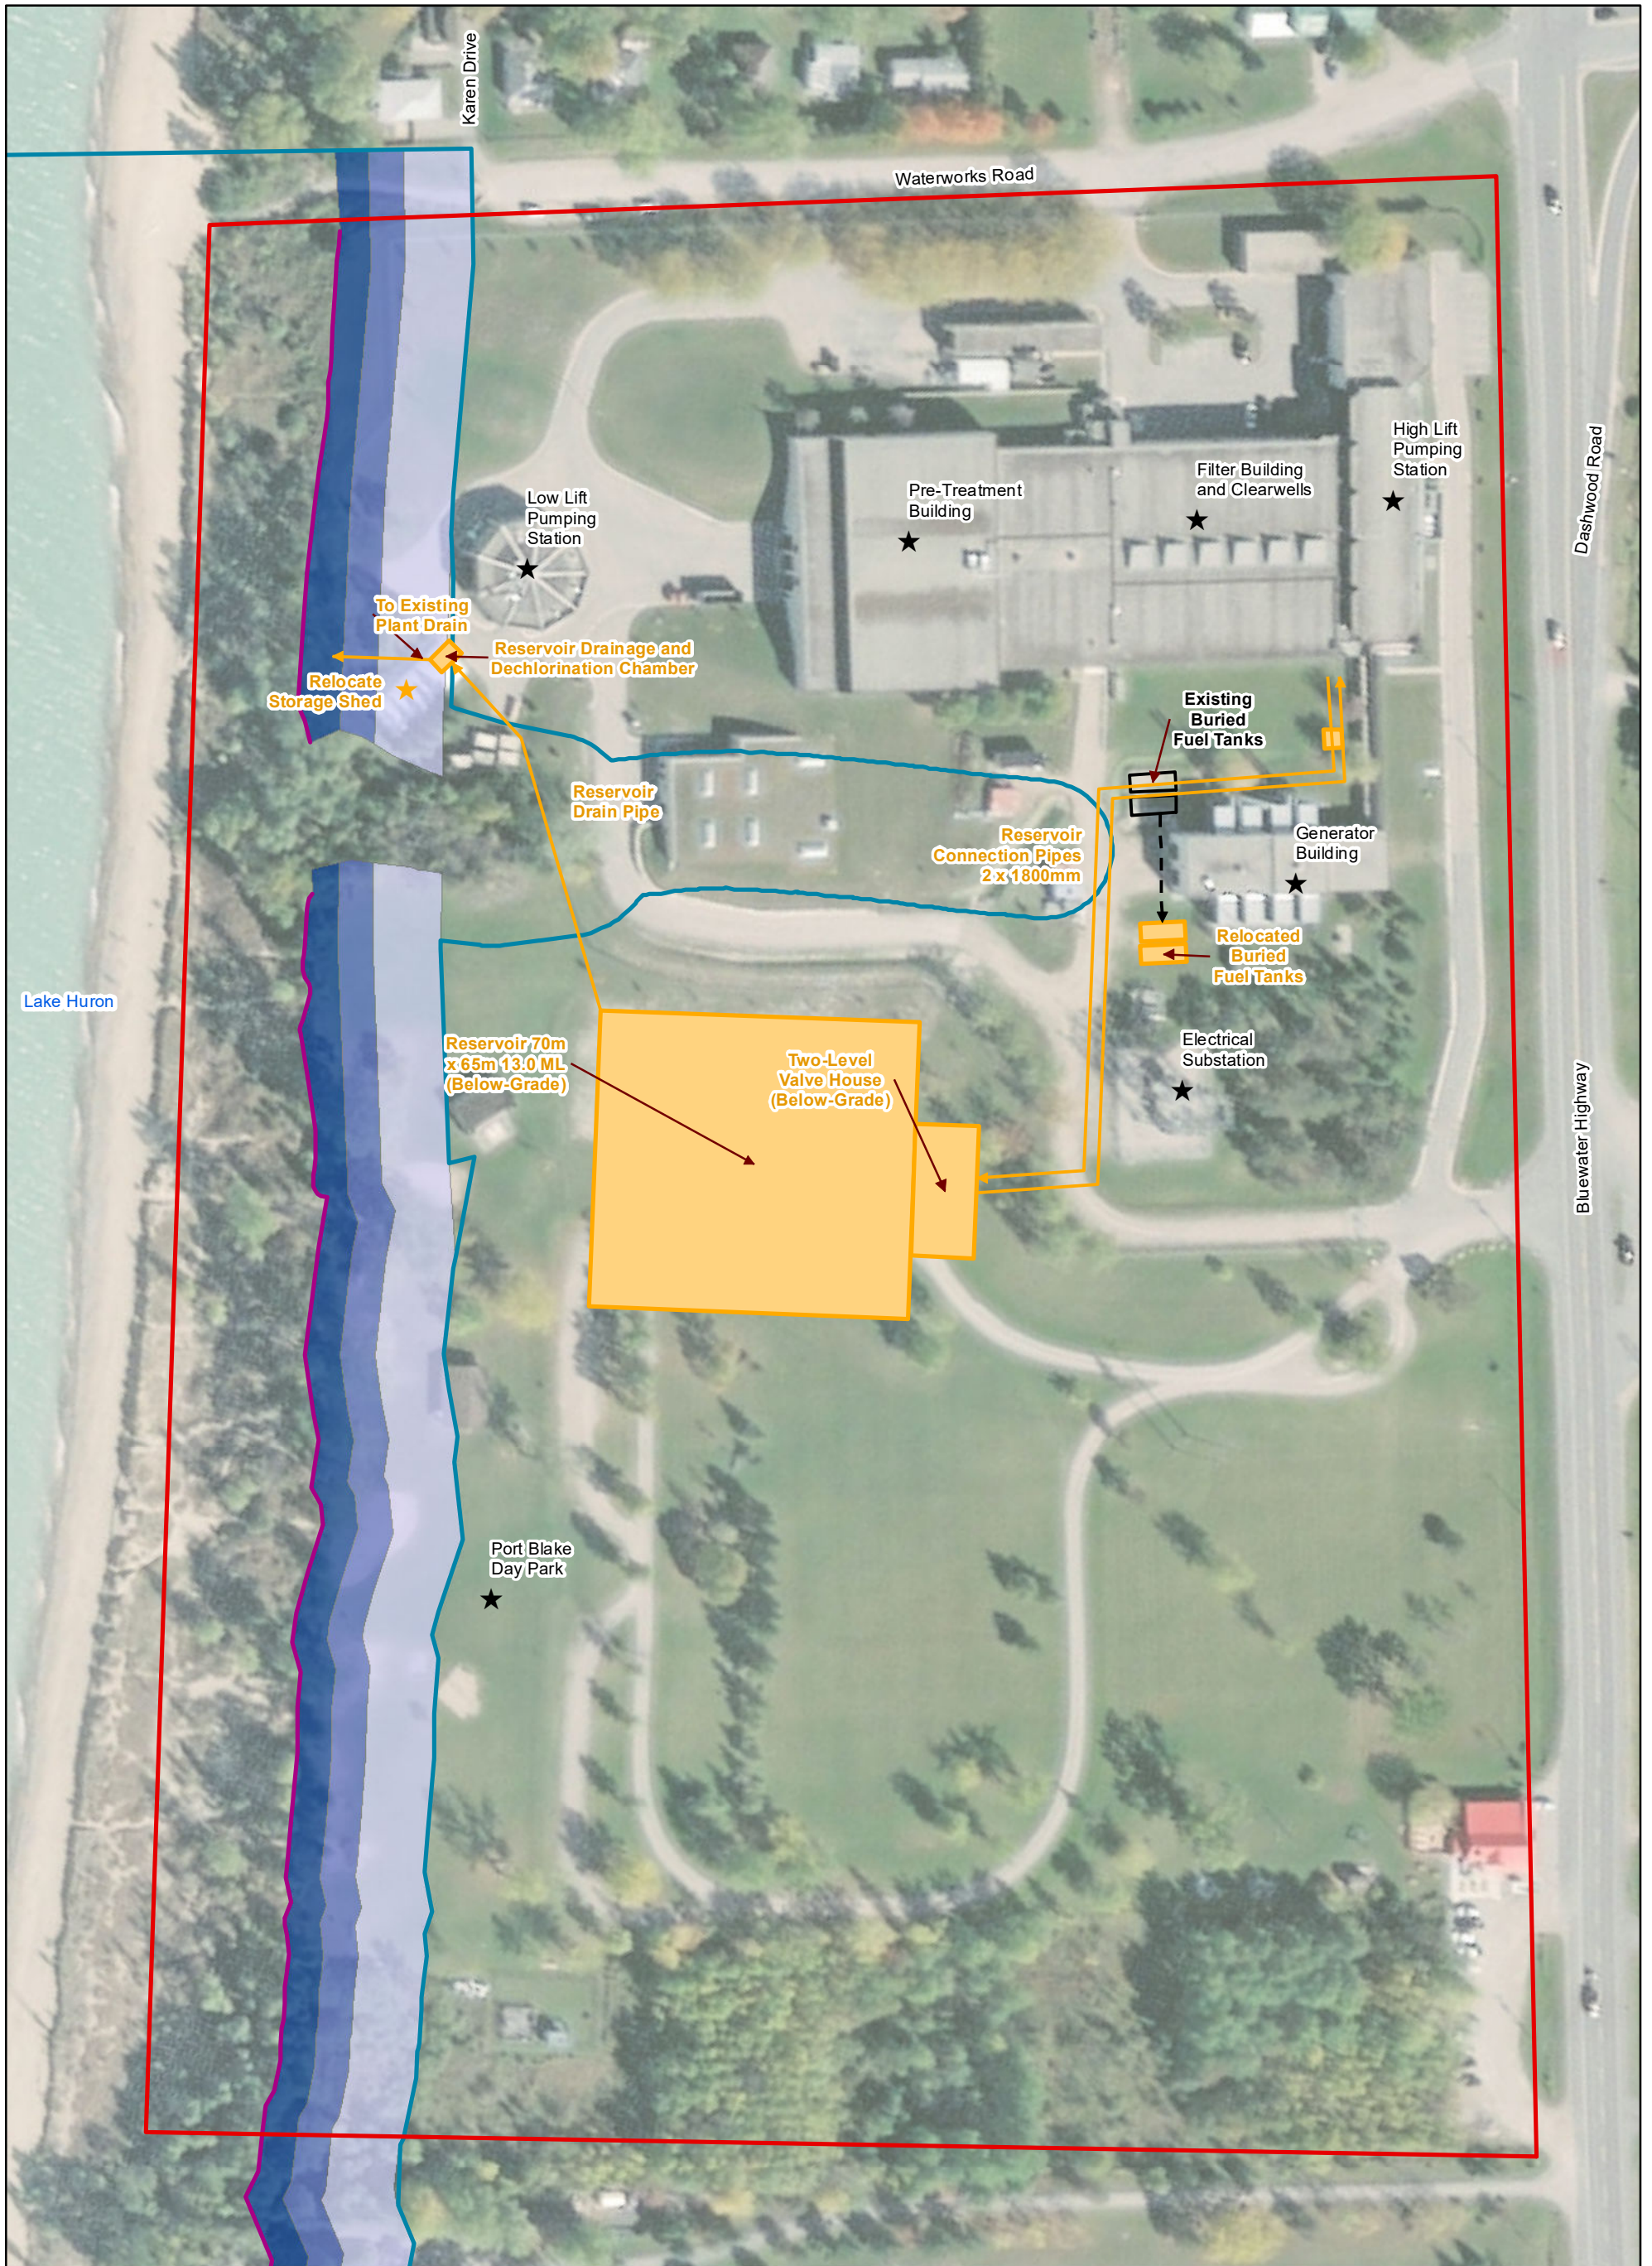
Figure 2
Alternative 3
Baseline Ecological Technical Memorandum
Lake Huron Water Treatment Plant Disinfection and Storage Upgrades EA
Lake Huron Primary Water Supply System
71155 Bluewater Hwy, Grand Bend, Ontario

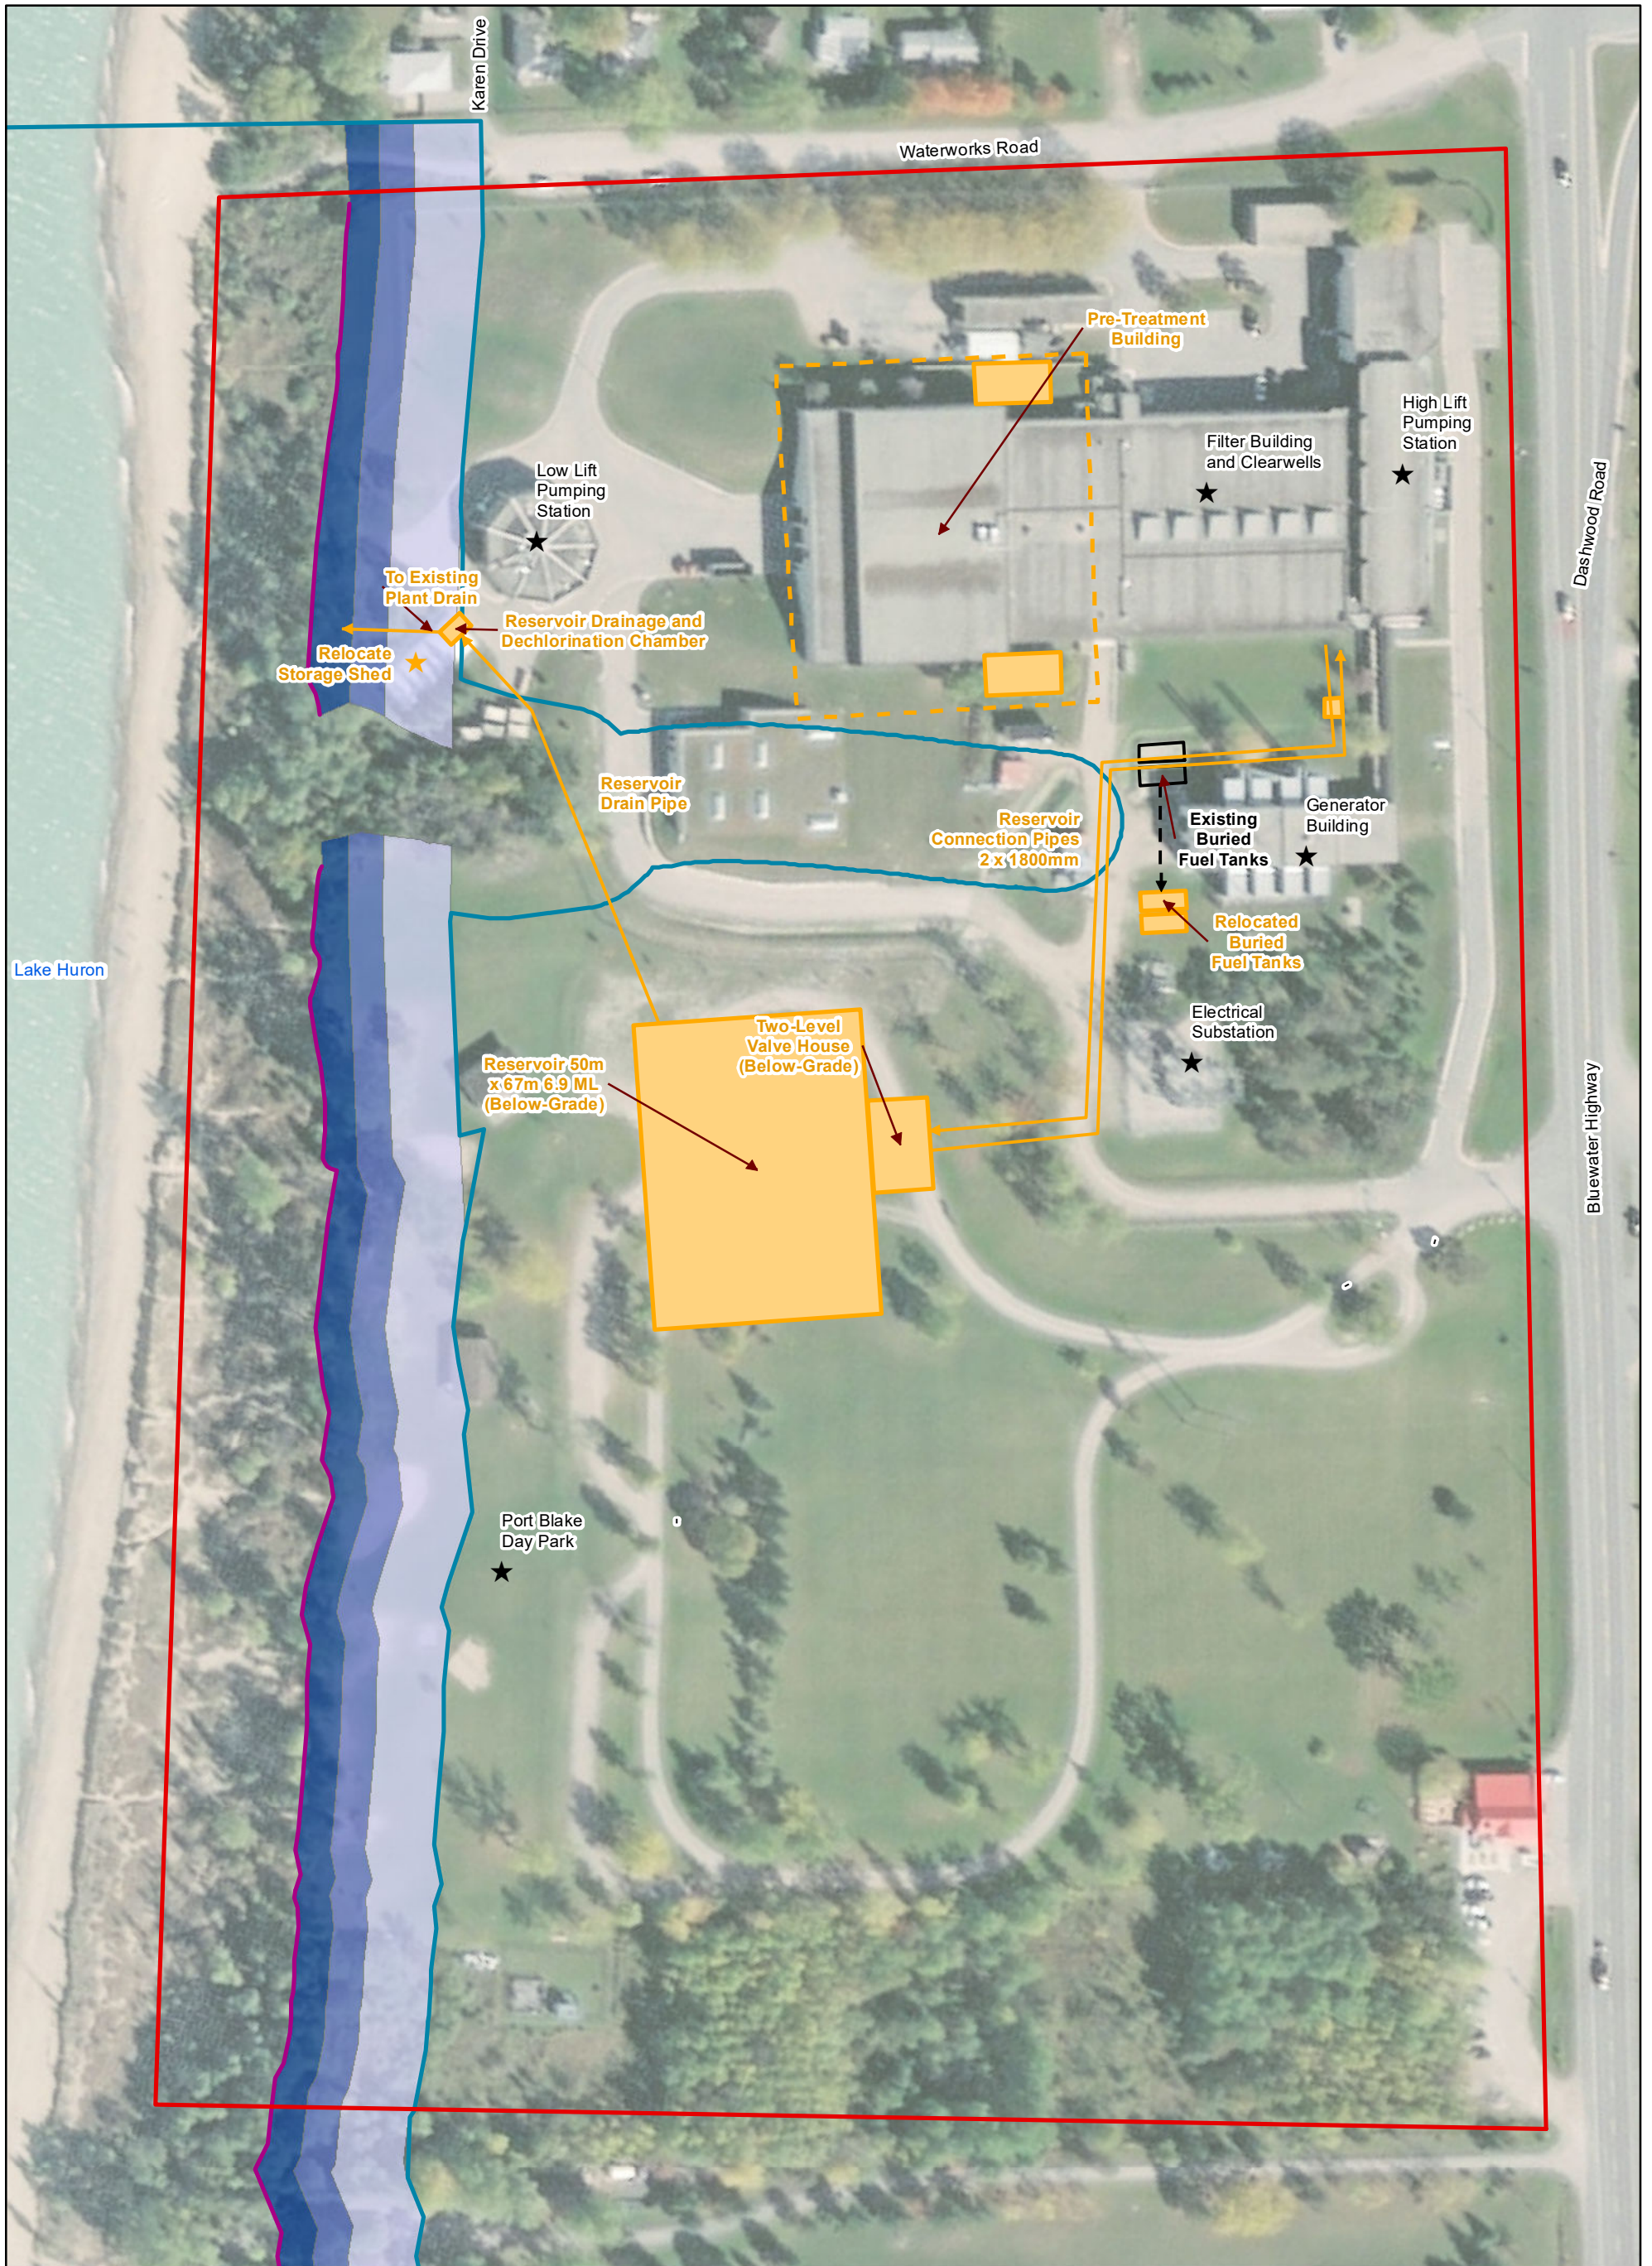
Figure 3
Alternative 4.1
Baseline Ecological Technical Memorandum
Lake Huron Water Treatment Plant Disinfection and Storage Upgrades EA
Lake Huron Primary Water Supply System
71155 Bluewater Hwy, Grand Bend, Ontario

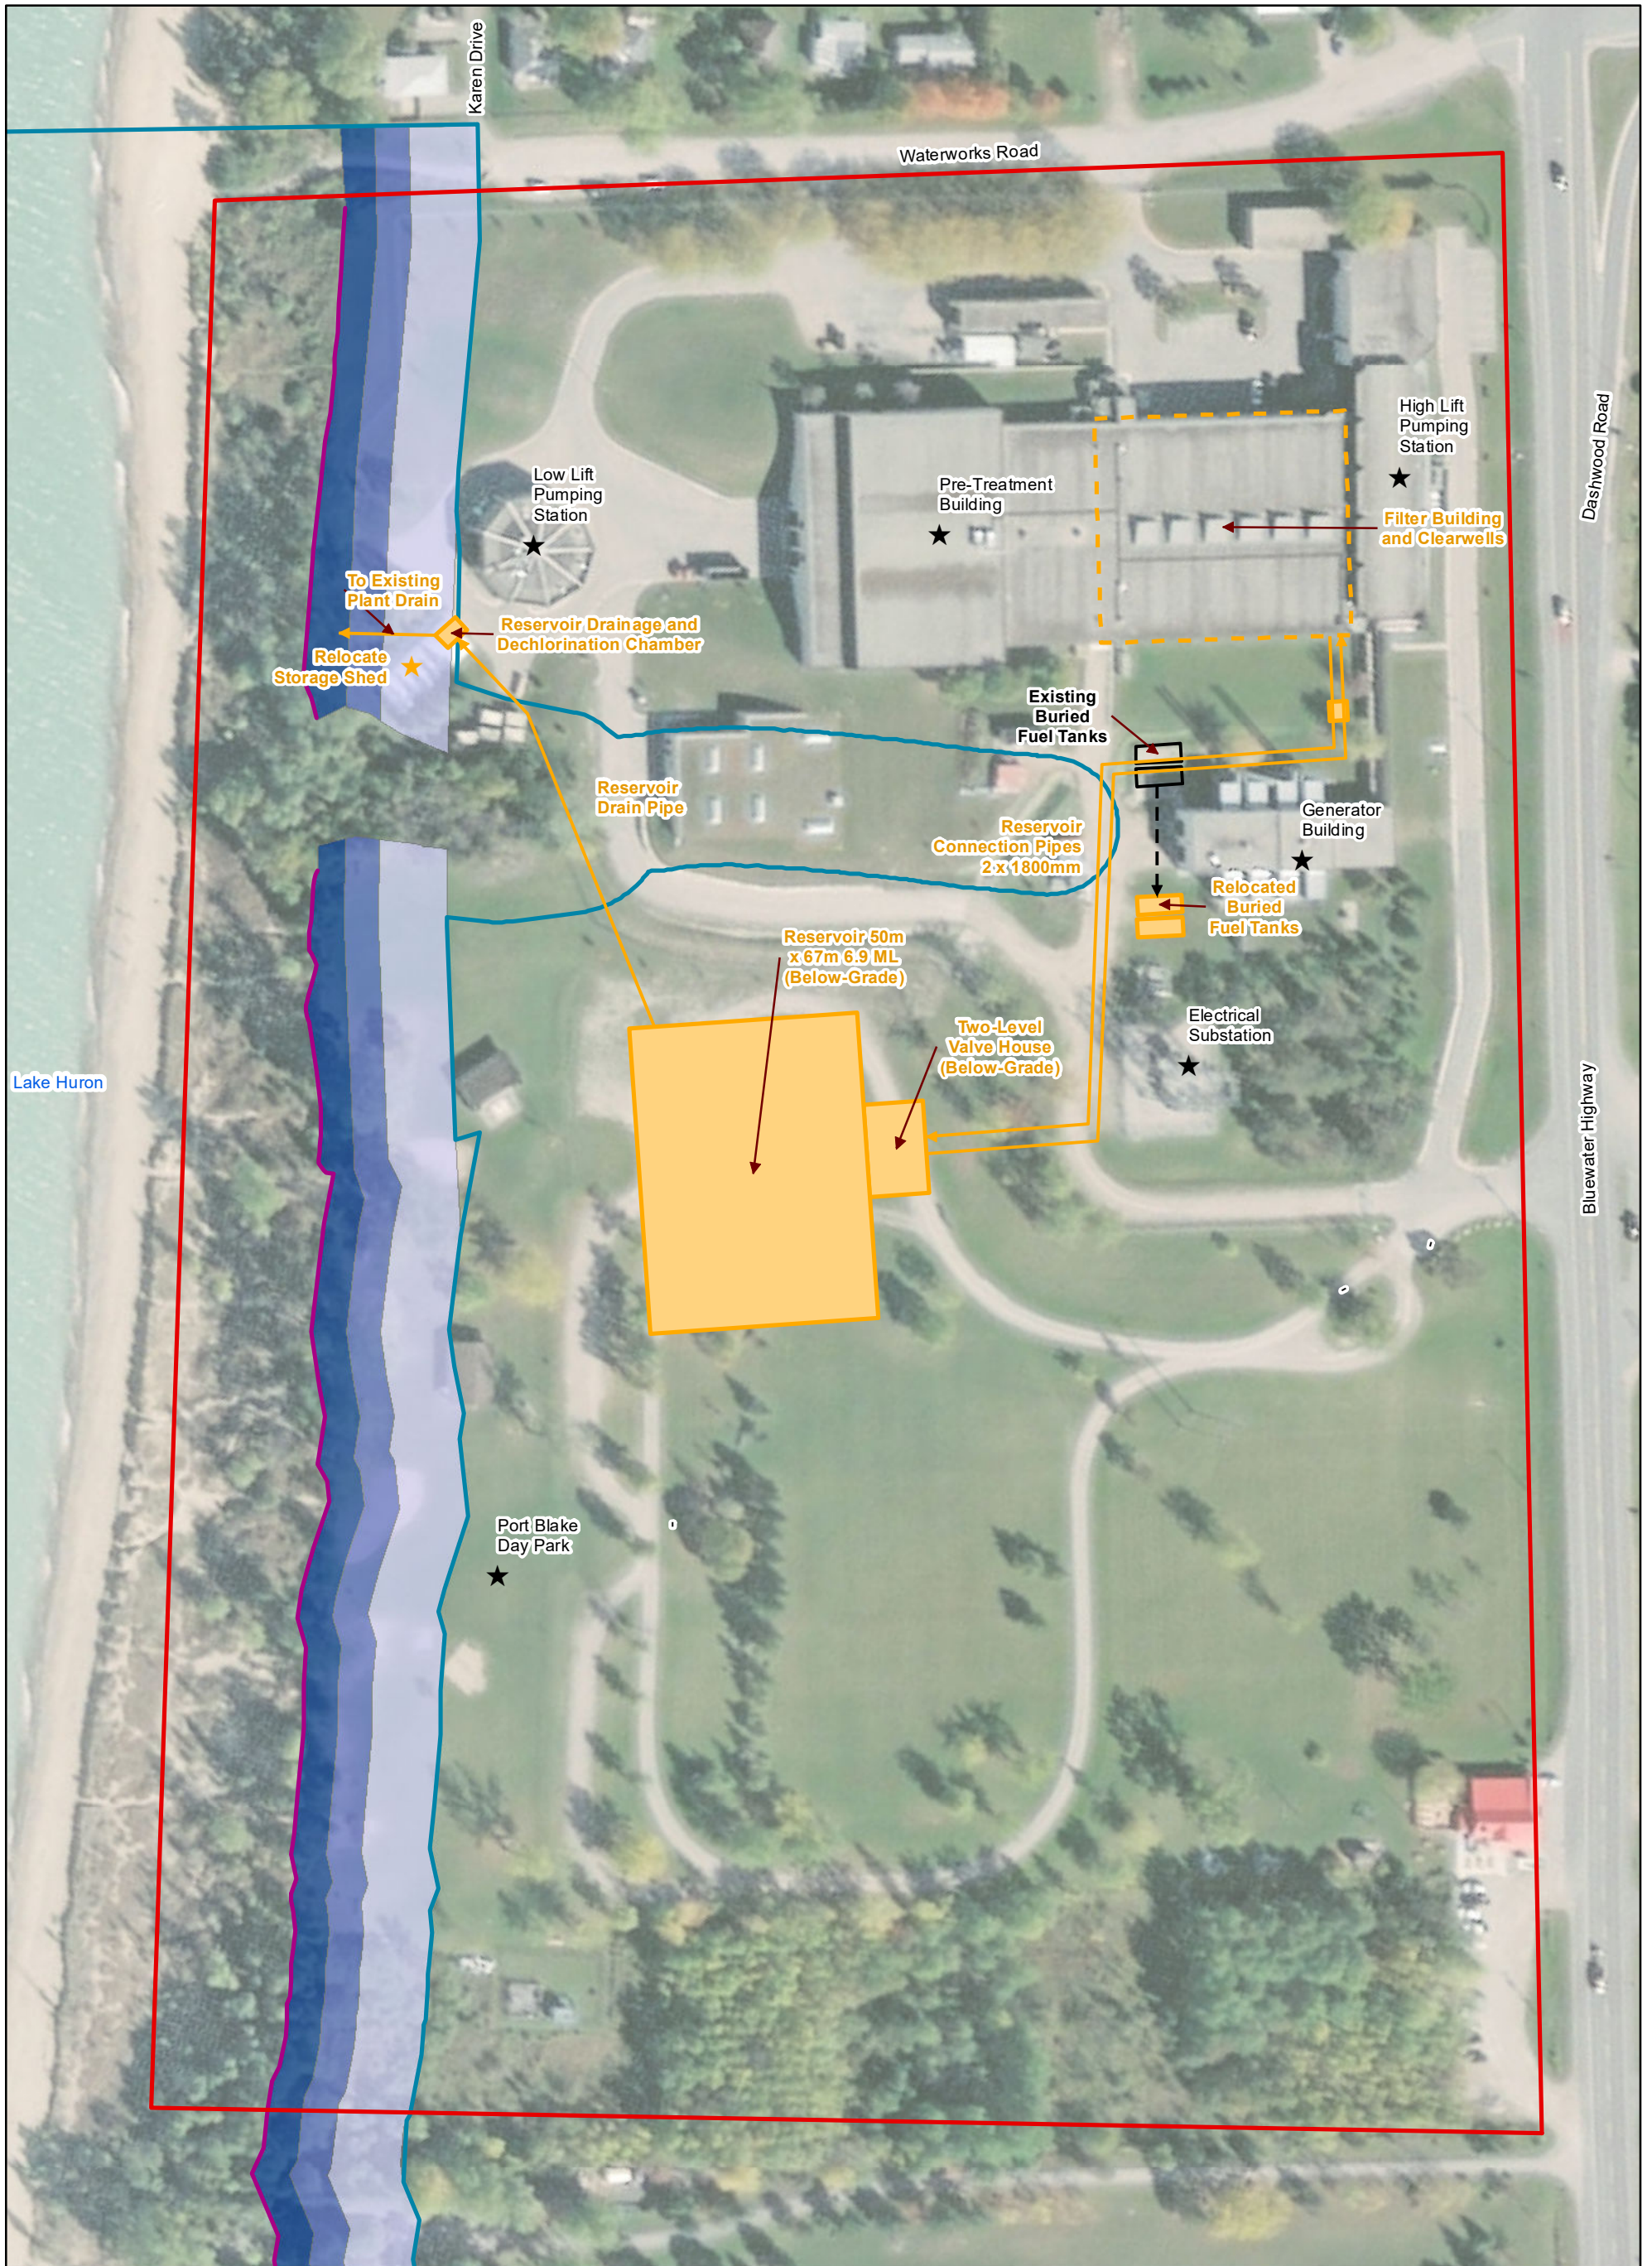
Figure 4
 Alternative 4.2
 Baseline Ecological Technical Memorandum
 Lake Huron Water Treatment Plant Disinfection and Storage Upgrades EA
 Lake Huron Primary Water Supply System
 71155 Bluewater Hwy, Grand Bend, Ontario

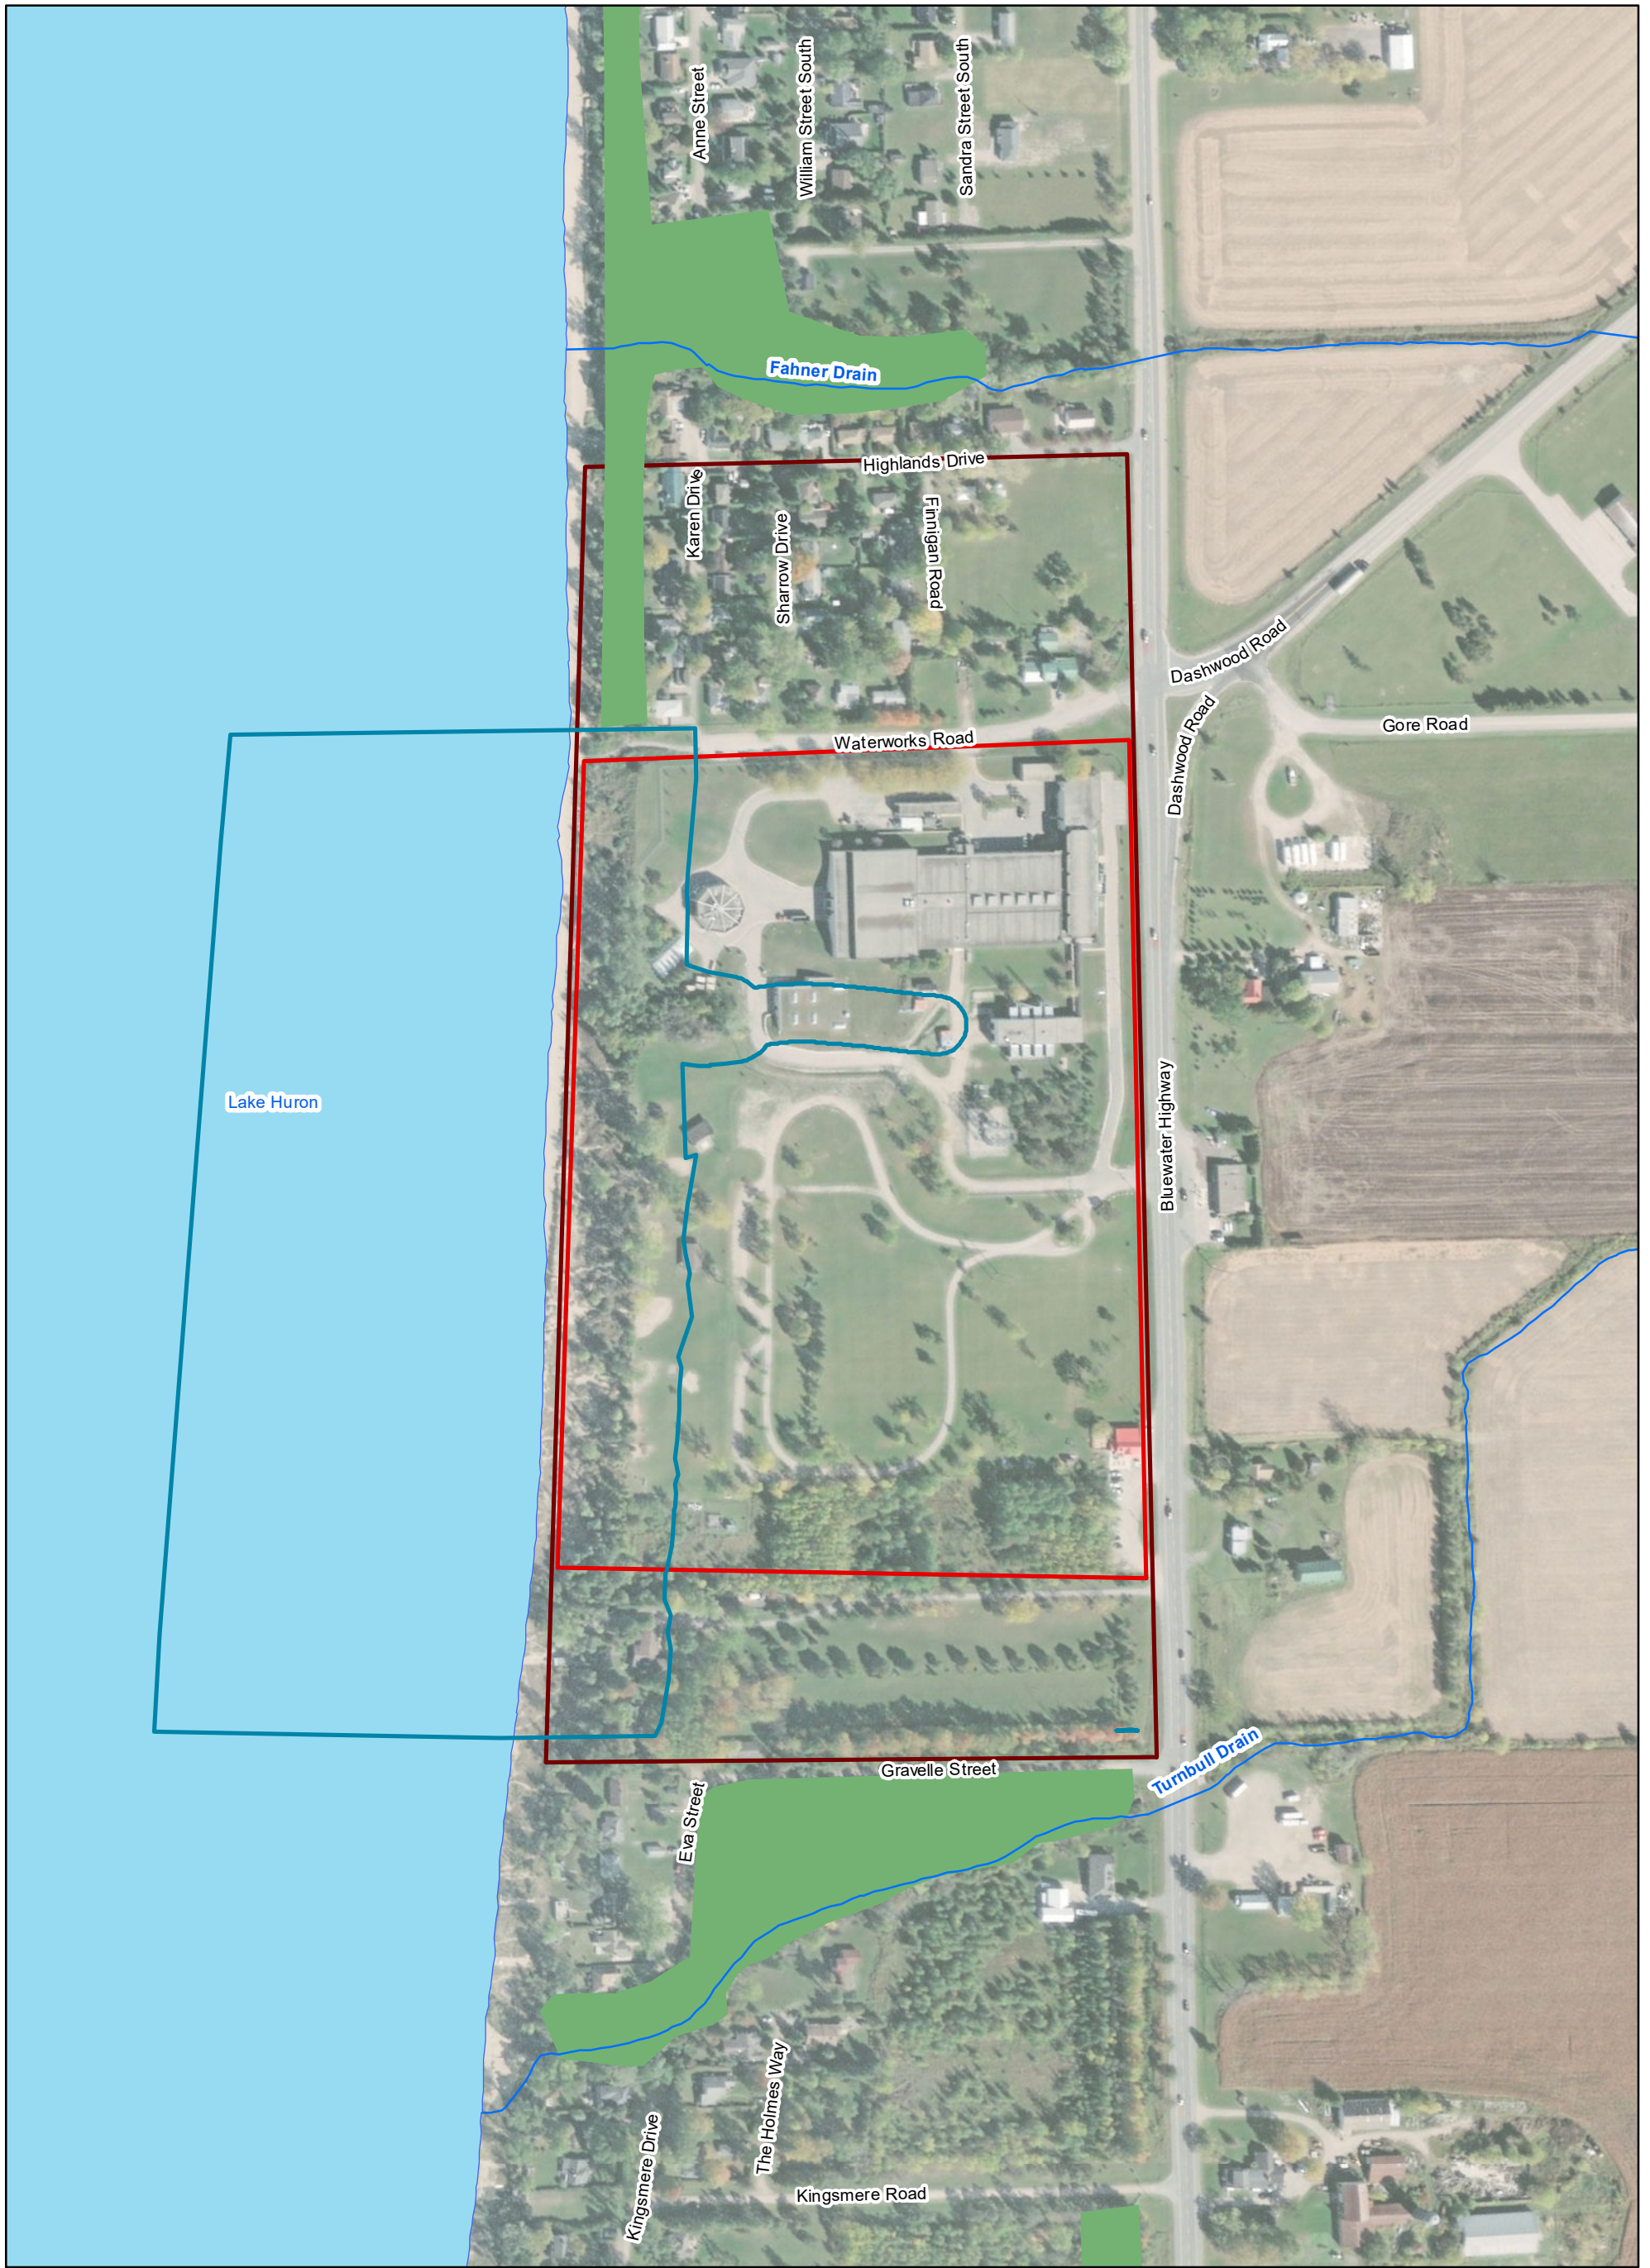
Figure 7
 Desktop Background Natural Features
 Baseline Ecological Technical Memorandum
 Lake Huron Water Treatment Plant Disinfection and Storage
 Upgrades EA Lake Huron Primary Water Supply System
 71155 Bluewater Hwy, Grand Bend, Ontario

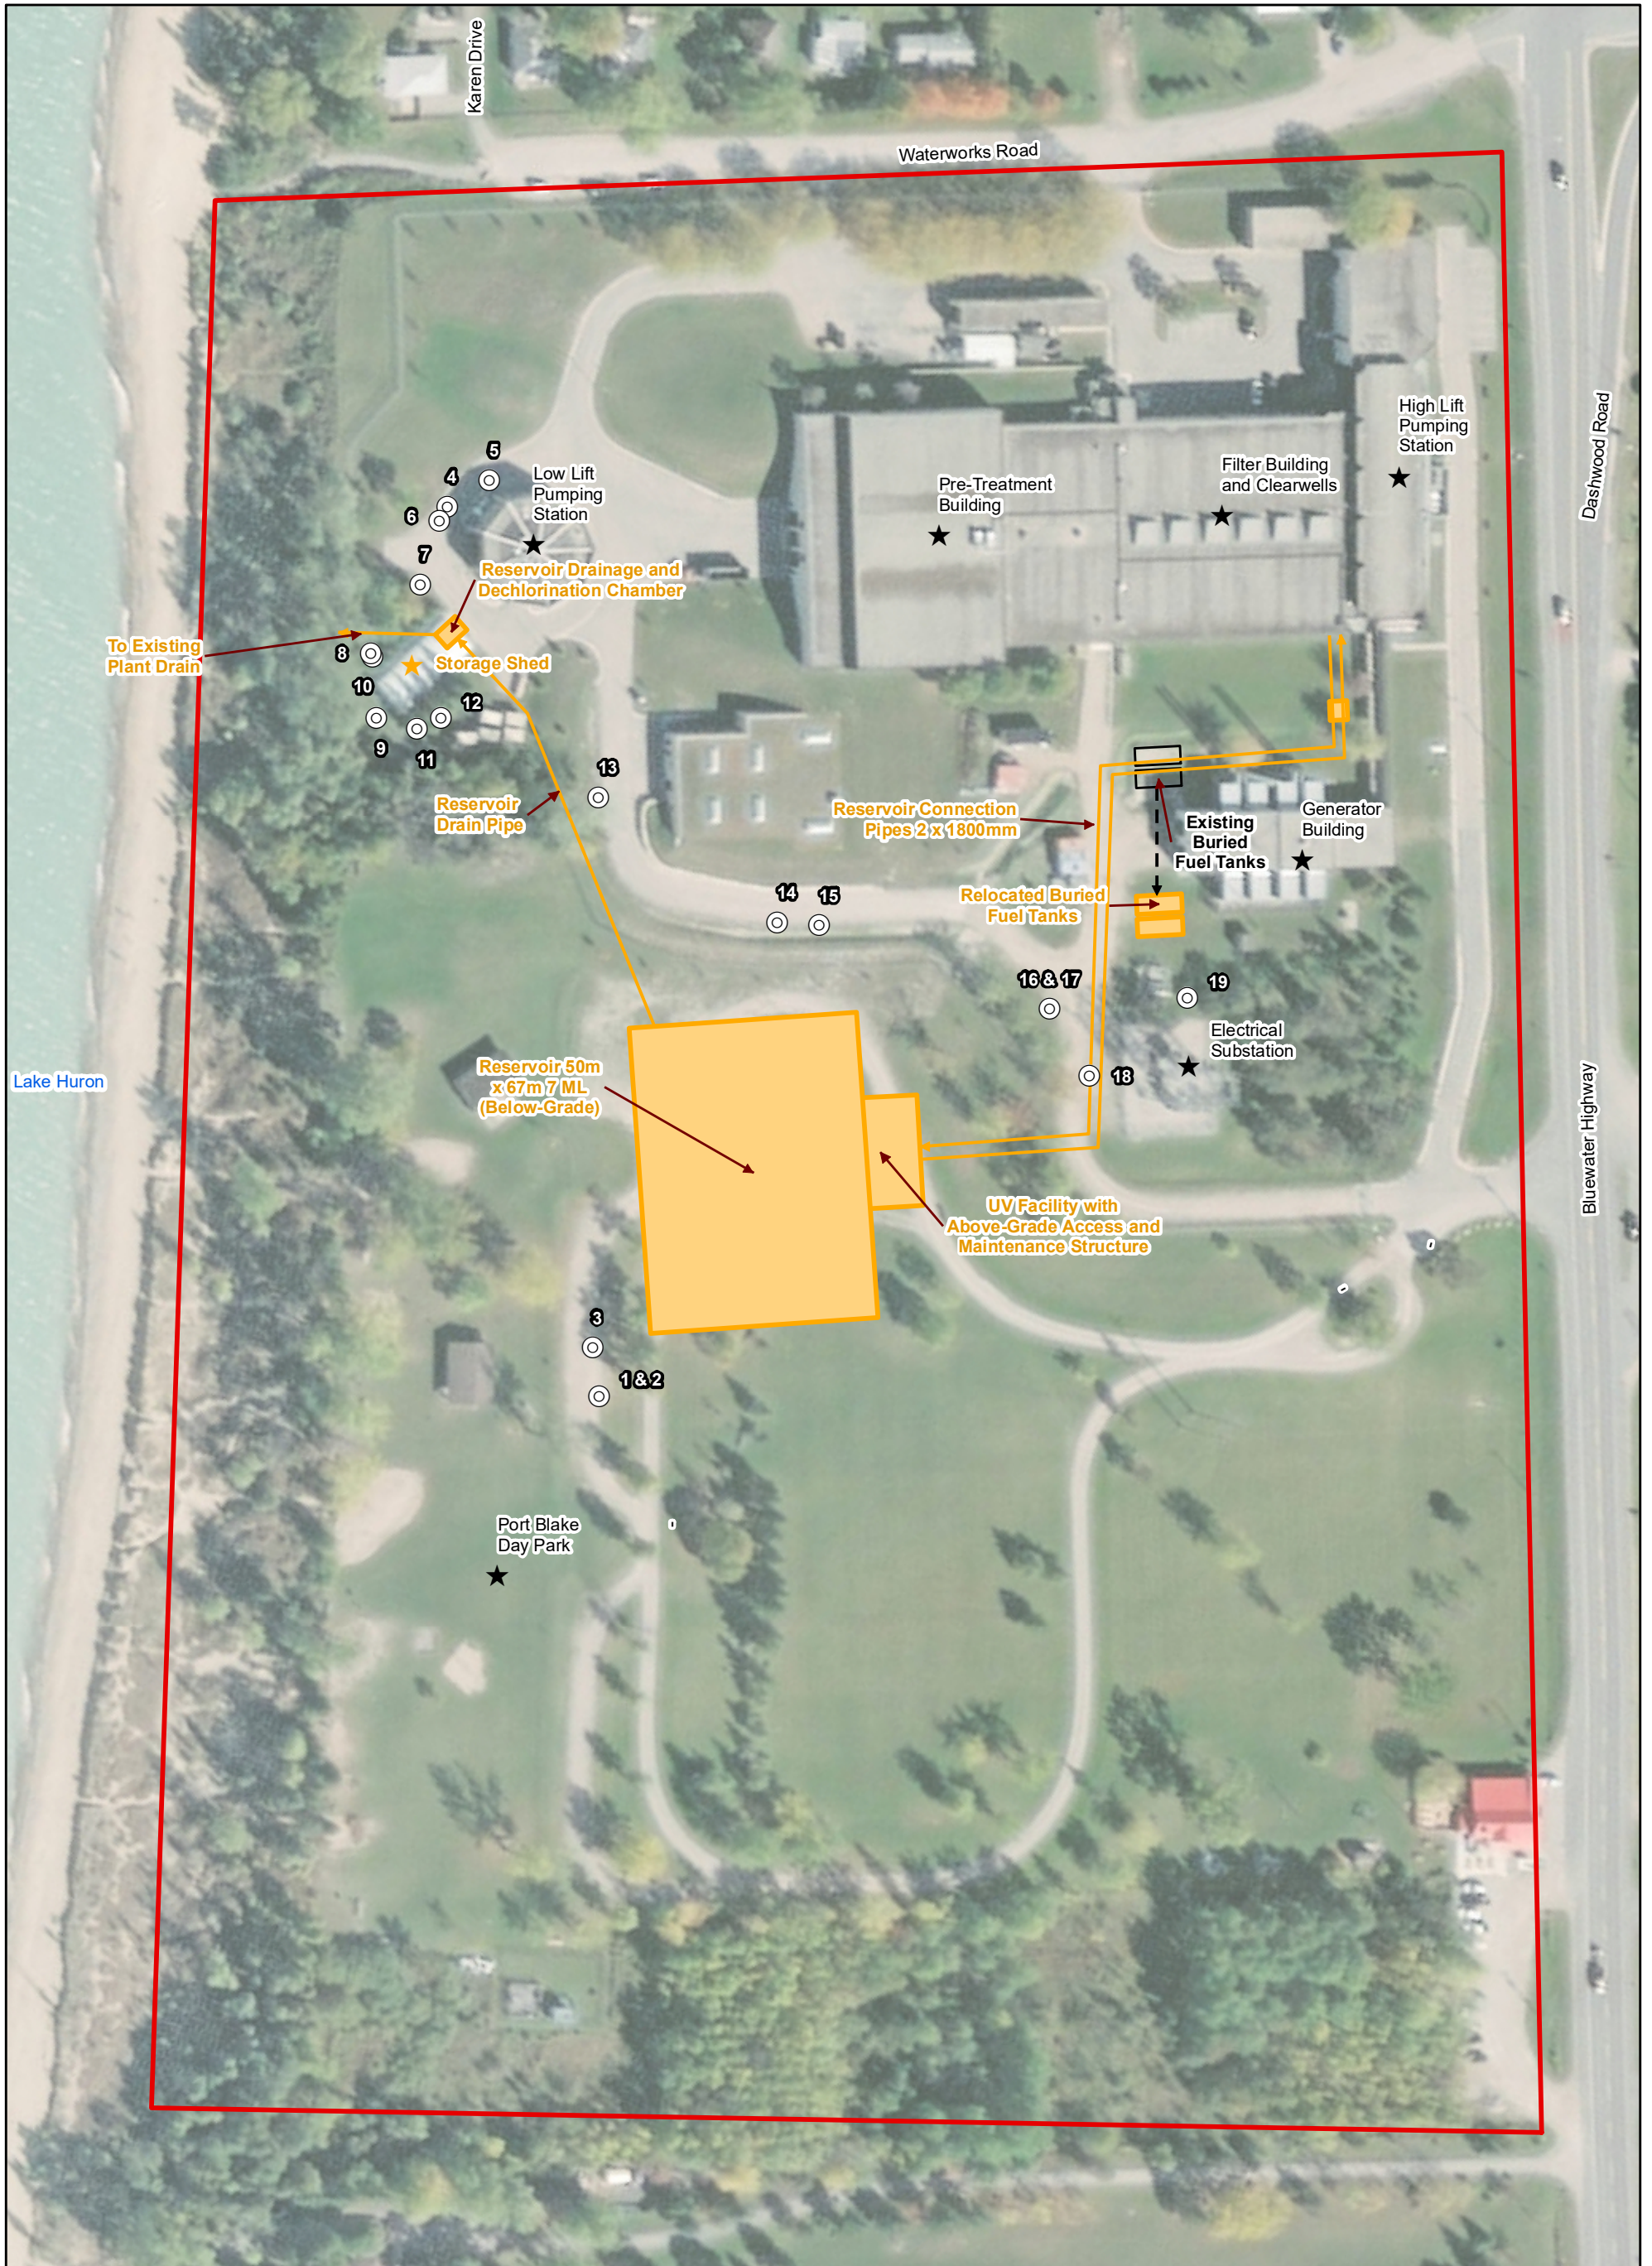
This TM does not include a comprehensive impact assessment or natural environment mitigation. Alternative 4.3 occurs within the Ausable Bayfield Conservation Authority (ABCA) Regulated Area and adjacent to Natural Features, as discussed within the following subsequent sections. However, an Environmental Impact Study (EIS) would only be requested by the ABCA if Species at Risk (SAR) occur or if Alternative 4.3 results in vegetation removals within Natural Features as per consultation with the ABCA. Natural Features and SAR will be discussed in the following sections. The Project Site is defined as the Water Treatment Plant (WTP) property and the potential area which could be impacted by the proposed works (Figure 1).

Figure 1
Alternative 4.3
Natural Features Field Assessment Technical Memorandum
Lake Huron Water Treatment Plant Disinfection and Storage Upgrades EA
Lake Huron Primary Water Supply System
71155 Bluewater Hwy, Grand Bend, Ontario

The project should consider shifting the proposed Reservoir Drain Pipe alignment to avoid impacts to the FOD4 forested area. Shifting the location of the Reservoir Drain Pipe to avoid vegetation removals within the FOD4 forests would then avoid an EIS request from ABCA. Additional mitigation and recommendations such as Erosion and Sediment Controls (ESC) would also be required to avoid indirect impacts to adjacent Natural Features.
