Natural Features Technical Memoranda

Appendix A1 – Desktop Natural Features Assessment

Project Name: Lake Huron Water Treatment Plant Disinfection and Storage Upgrades Class Environmental Assessment

Project Number: CE801200

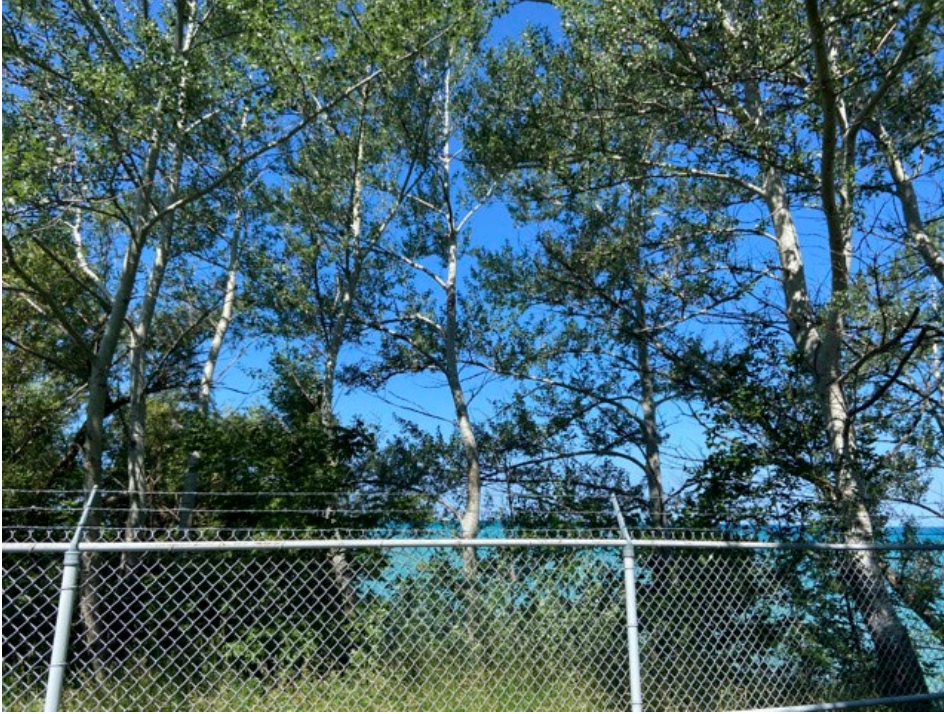
The FOD8-1 ecotone canopy was dominated by White Poplar (*Populus alba*). The sub-canopy was co-dominated by Crack Willow (*Salix euxina*) and Black Walnut (*Juglans nigra*). The FOD8-1 community groundcover was dominated by Kentucky Bluegrass. The following species were identified within the FOD8-1 community:

Photo 8. FOD8-1 Fresh – Moist Poplar Deciduous Forest Type ecotone, facing west.

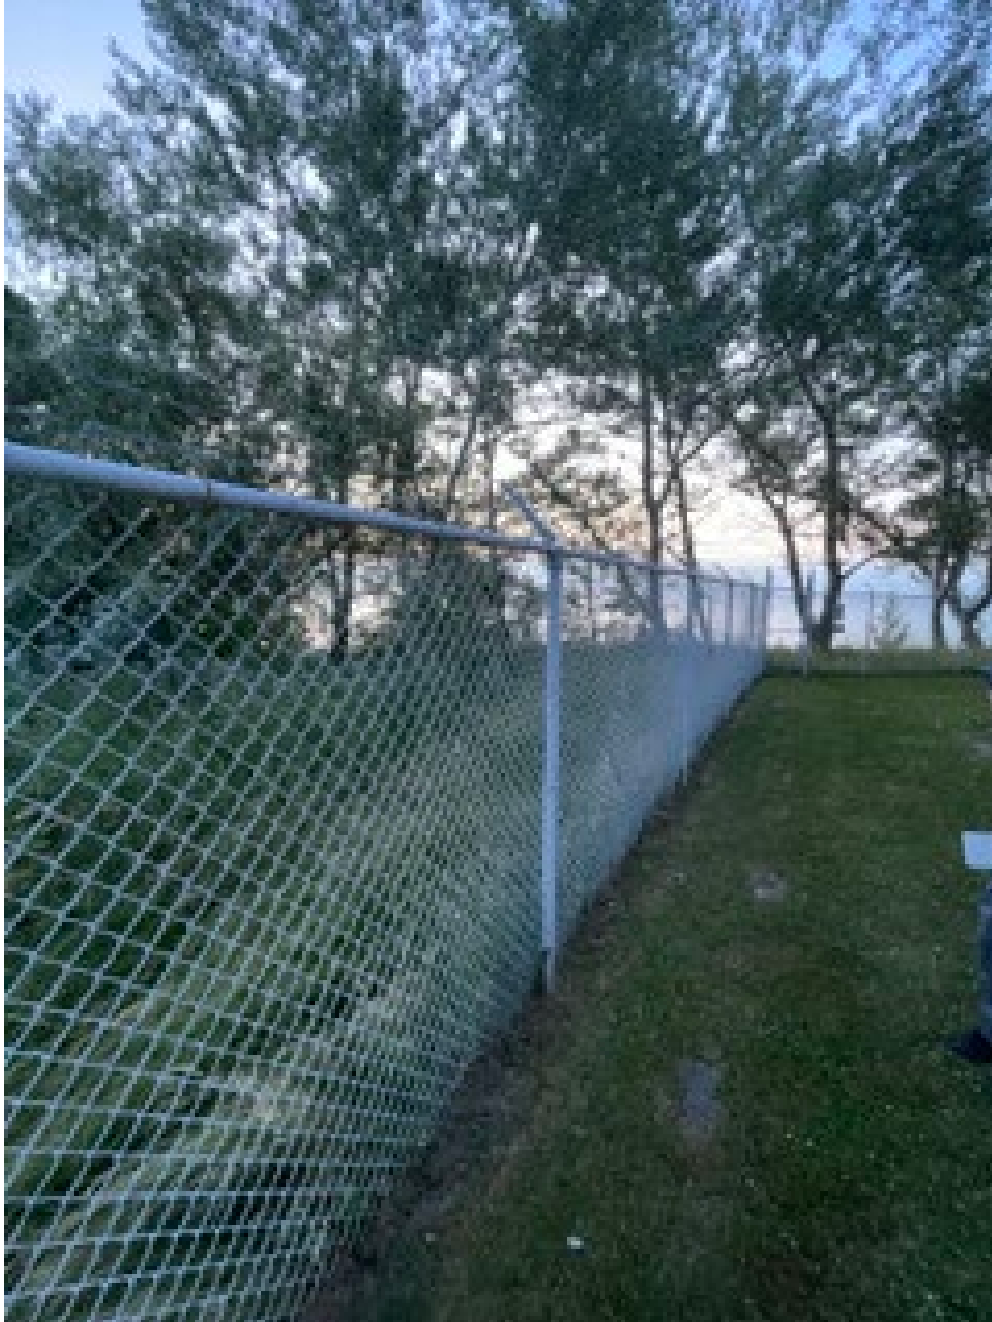
Photo 9. FOD8-1 Fresh – Moist Poplar Deciduous Forest Type community, facing west.

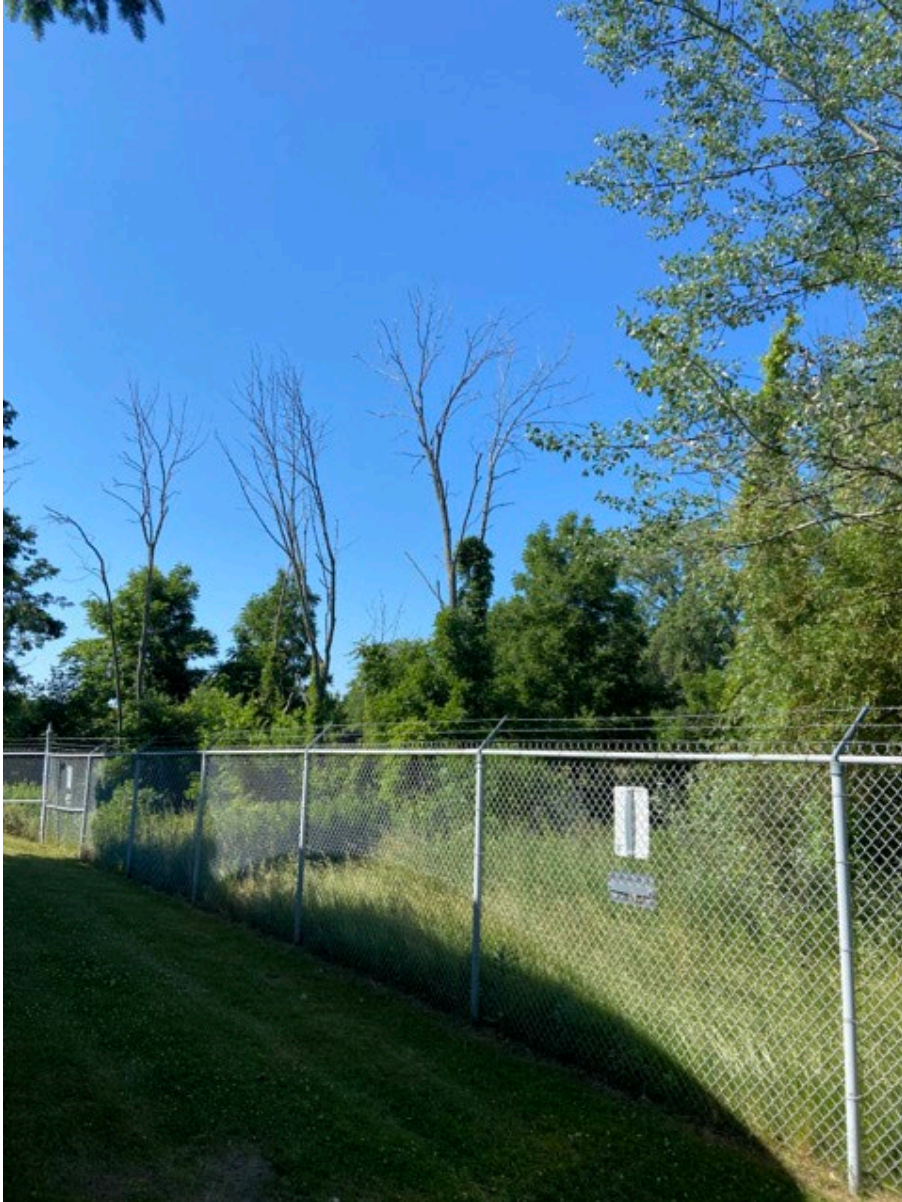
Photo 10. FOD4 Dry – Fresh Deciduous Forest Ecosite from inside plant fence, facing southeast.

The project should consider shifting the proposed Reservoir Drain Pipe alignment to avoid impacts to the FOD4 forested area. Shifting the location of the Reservoir Drain Pipe to avoid vegetation removals within the FOD4 forests would then avoid an EIS request from ABCA. Additional mitigation and recommendations such as Erosion and Sediment Controls (ESC) would also be required to avoid indirect impacts to adjacent Natural Features.

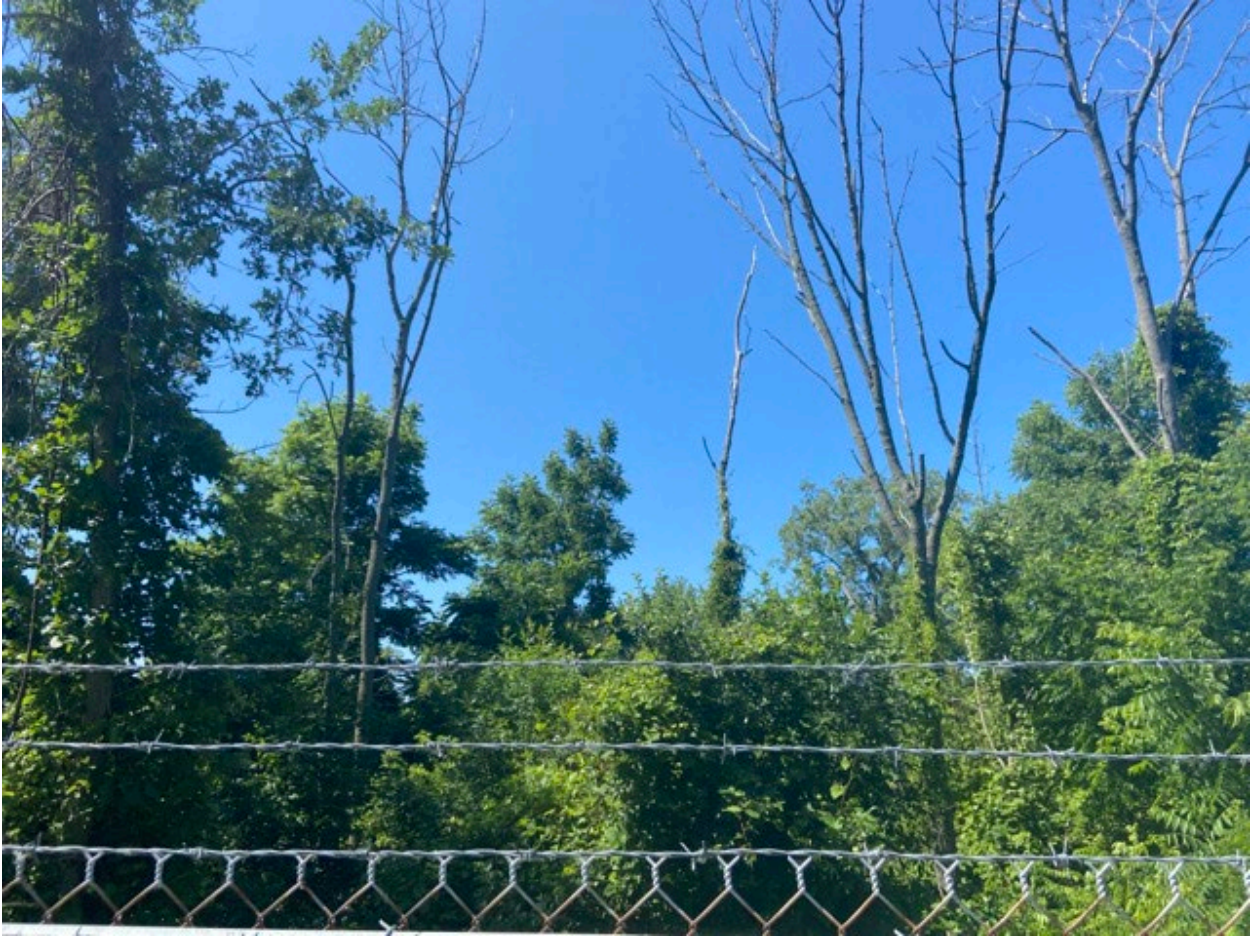
Photo 11. FOD4 Dry – Fresh Deciduous Forest Ecosite community, facing south.

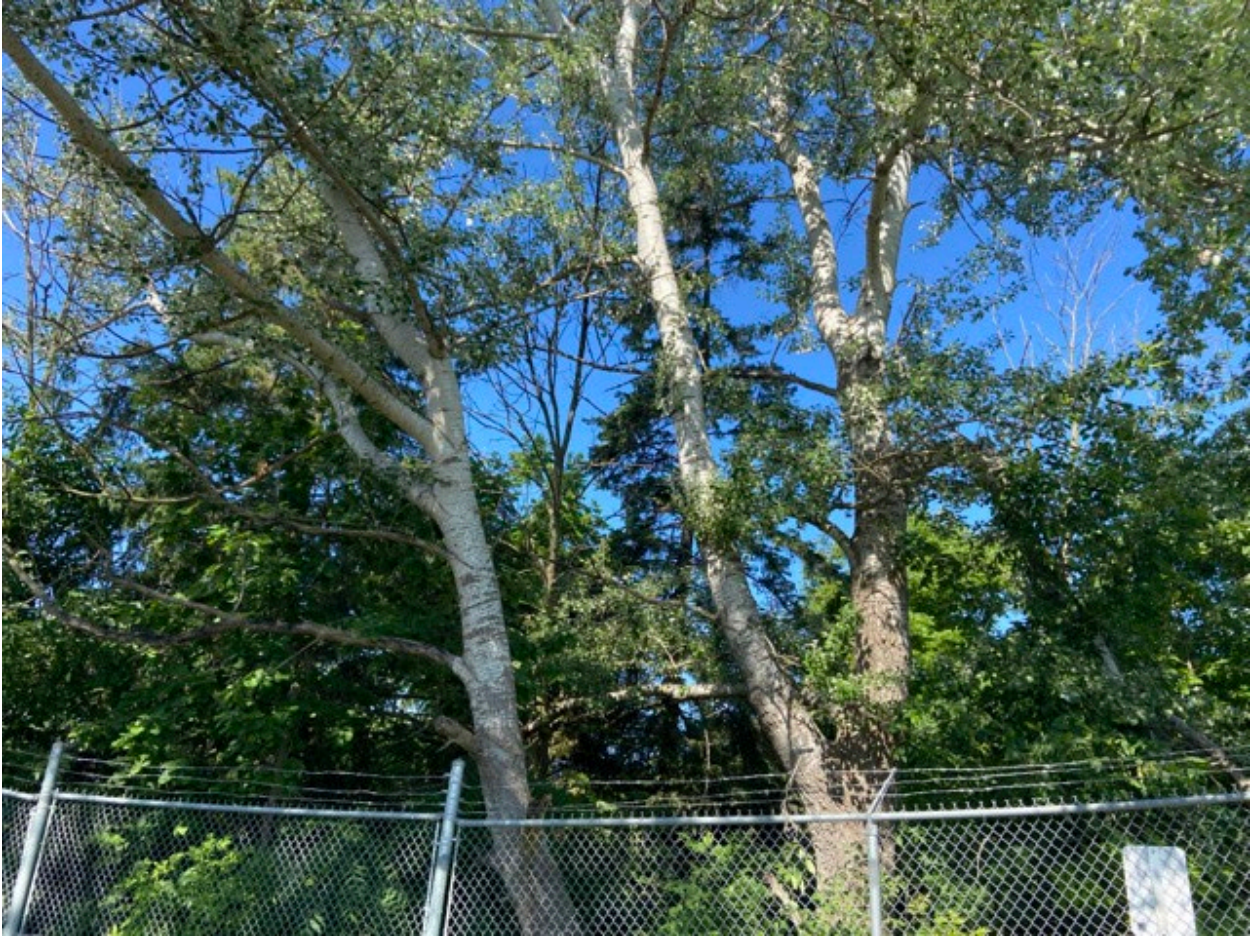
Photo 13. FOD4 Dry – Fresh Deciduous Forest Ecosite community, facing southwest.

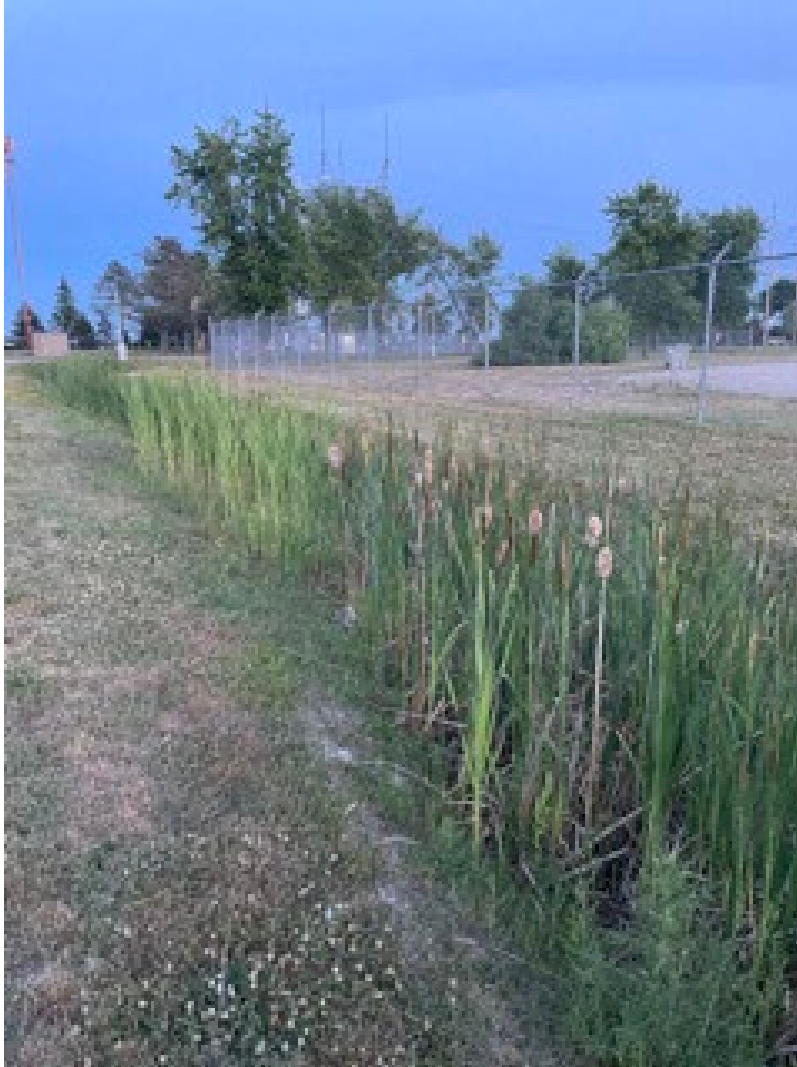
Photo 14. MAS2-1 Cattail Mineral Shallow Marsh Type drainage swale, facing southeast.

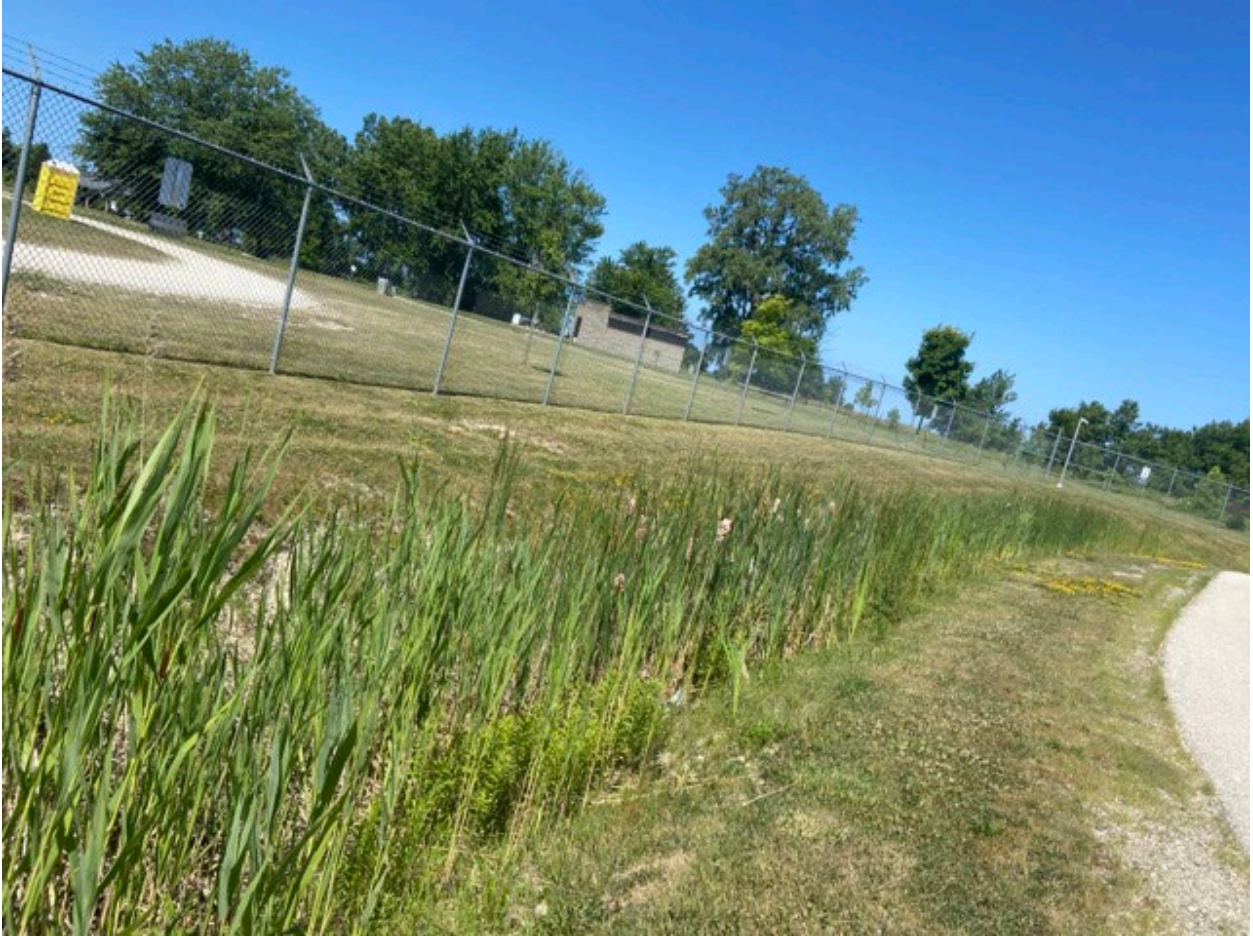
Photo 15. MAS2-1 Cattail Mineral Shallow Marsh Type drainage swale, facing southwest.
